TURBULENCE JOINT SAFETY ANALYSIS TEAM (JSAT)

Analysis and Results
January 12, 2001

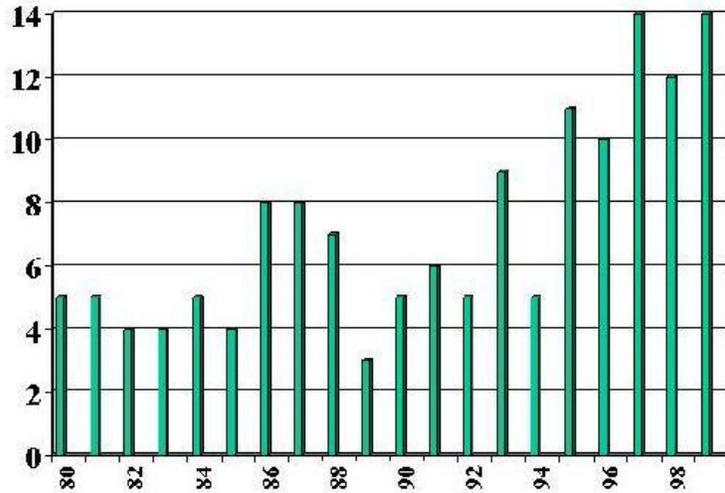
Figure 1: Number of Turbulence Accidents, US Air Carriers, 1980-1999
 Source: NTSB Accident Data, compiled by Dr. Robert Matthews, Ph.D., Federal Aviation Administration, Office of Accident Investigations

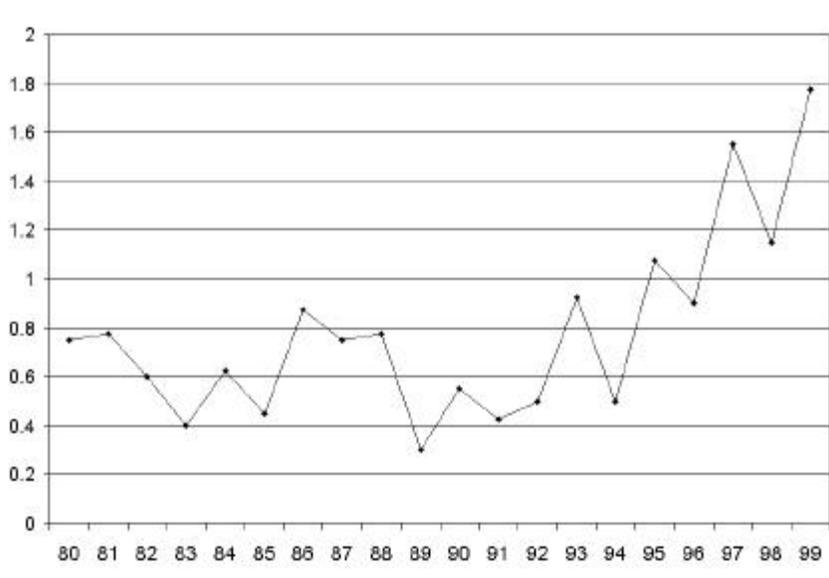
Figure 2: Turbulence Accidents per Million Flights, US Carriers, Based on 14 CFR 119 Definition
 Source: NTSB Accident Data, compiled by Dr. Robert Matthews, Ph.D., Federal Aviation Administration, Office of Accident Investigations

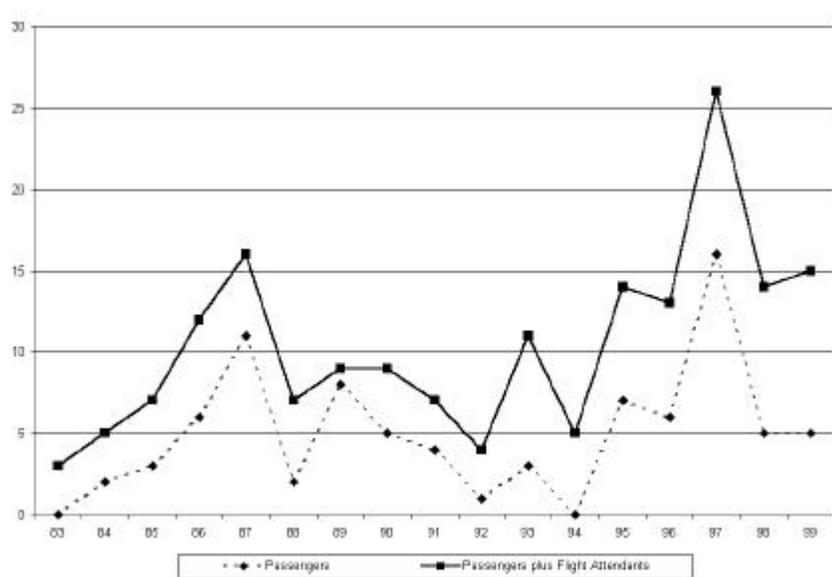
**Figure 3: Serious Injuries to Passengers and Flight Attendants in Turbulence Accidents, 1983-1999
(Includes three fatal passenger injuries)**

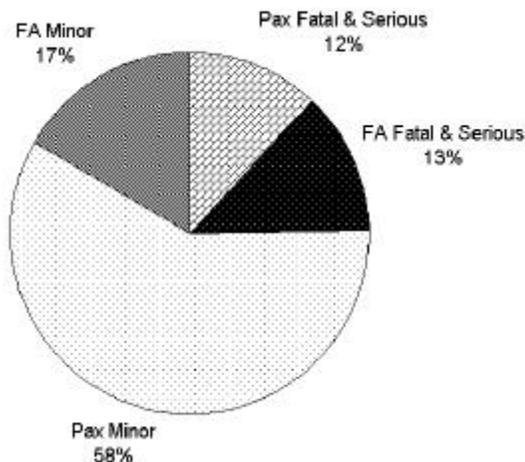
Passengers accounted for almost 94 percent of persons onboard the 131 accident aircraft, but they accounted for only 48 percent of the fatal and serious injuries, and close to 78 percent of minor injuries. In contrast, flight attendants accounted for just over four percent of people onboard but 52 percent of serious or fatal injuries and over 22 percent of minor injuries. The incidence of serious injury in turbulence was nearly 24 times higher per flight attendant than the risk per passenger, while the risk of minor injury was more than six times higher.

Figure 5: Breakdown of Total Passenger and Flight Attendant Injuries

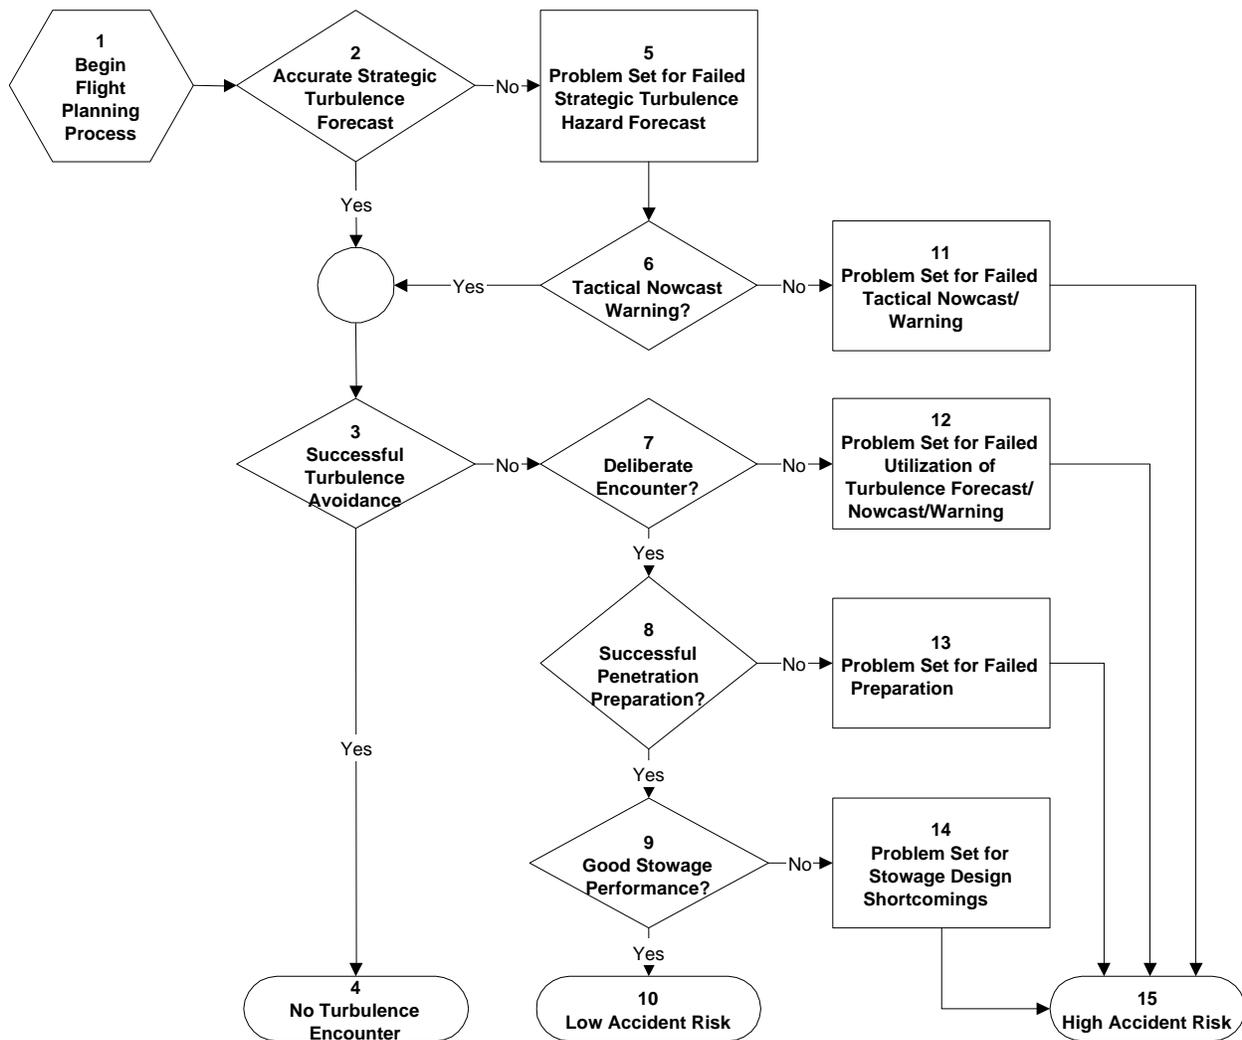
Figure 6: Turbulence Avoidance and Mitigation Flow Chart

In the no-risk scenario, the aircraft completely avoids turbulence. Complete avoidance can be achieved via two paths in Figure 5. The first path is depicted in steps 1, 2, 3, and 4 in the Figure. In this scenario, the flight planner has and uses a valid strategic forecast that tells him/her the location and severity of turbulence, and the flight planner has an alternate route that is both free of turbulence and practical.

The second path to successful avoidance of the turbulence is via steps 1, 2, 5, 6, 3, and 4 in Figure 6. In this scenario, the flight planner does not have a reliable strategic turbulence forecast, but a sound tactical turbulence nowcast or warning becomes available during the flight sufficiently ahead of the turbulence, that an in-flight diversion around the turbulence is executed.

In reviewing turbulence accidents, the JSAT documented a series of problems leading to failure of flight planners to flight plan or deviate around turbulence. These problems are categorized as follows: (1) turbulence forecasts and warnings are inaccurate, missing or late (2) flight planners and/or flight crew overlook valid turbulence information and select turbulent routes or (3) there are impediments to changing a route to avoid the turbulence.

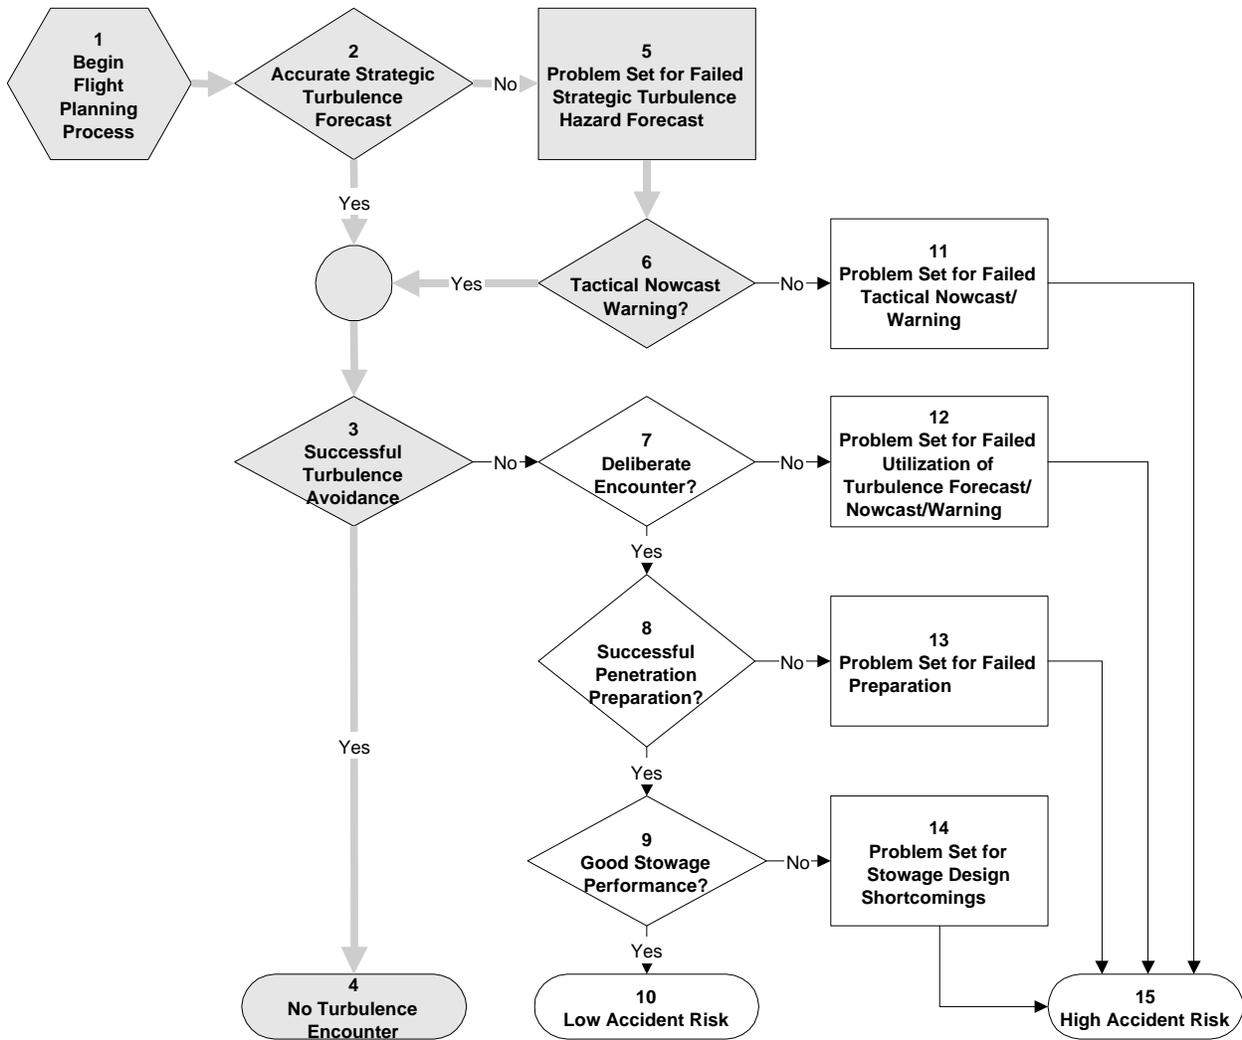
Figure 6a: Turbulence Avoidance and Mitigation Flow Chart -- No-Risk Scenario

The low-risk scenario, as depicted in Figure 6a, entails deliberate penetration of turbulence but with a secure cabin. A secure cabin means all equipment is secured and all passengers and cabin crew are seated and properly restrained before penetrating the turbulence. Deliberate penetration with a secure cabin follows one of two paths in Figure 6. The first and most direct path is via steps 1, 2, 3, 7, 8, 9, and 10. The second is via steps 1, 2, 5, 6, 3, 7, 8, 9, and 10. If equipment is unsecured when turbulence penetrations occur, collisions between equipment and people may cause injuries. If passengers or cabin crew are unrestrained when turbulence penetration occurs, they may be knocked off their feet or thrown to the floor, the ceiling, laterally against seats, other structures, or each other.

Failure to secure the cabin, cabin crew, and passengers may be caused by:

- *flight* crew failure to communicate to cabin crew and/or passengers turbulence warnings or directions to be seated/restrained [SPS #602]
- *cabin* crew failure to communicate to passengers turbulence warnings or directions to be seated/belted [SPS #612]
- flight attendant not seated or not belted when seated due to inadequate warning time and/or conflict with other duties [SPS #611]
- aircraft or equipment design shortcomings that prevent timely storage of equipment [SPS #632]
- failure by cabin crew to follow procedures to prevent injury to themselves or to passengers [SPS #603]
- aircraft design shortcomings that lead to failure of restraints or overhead bin doors [SPS #631]
- Willful failure by flight attendants or passengers to comply with turbulence warnings [SPS #641]

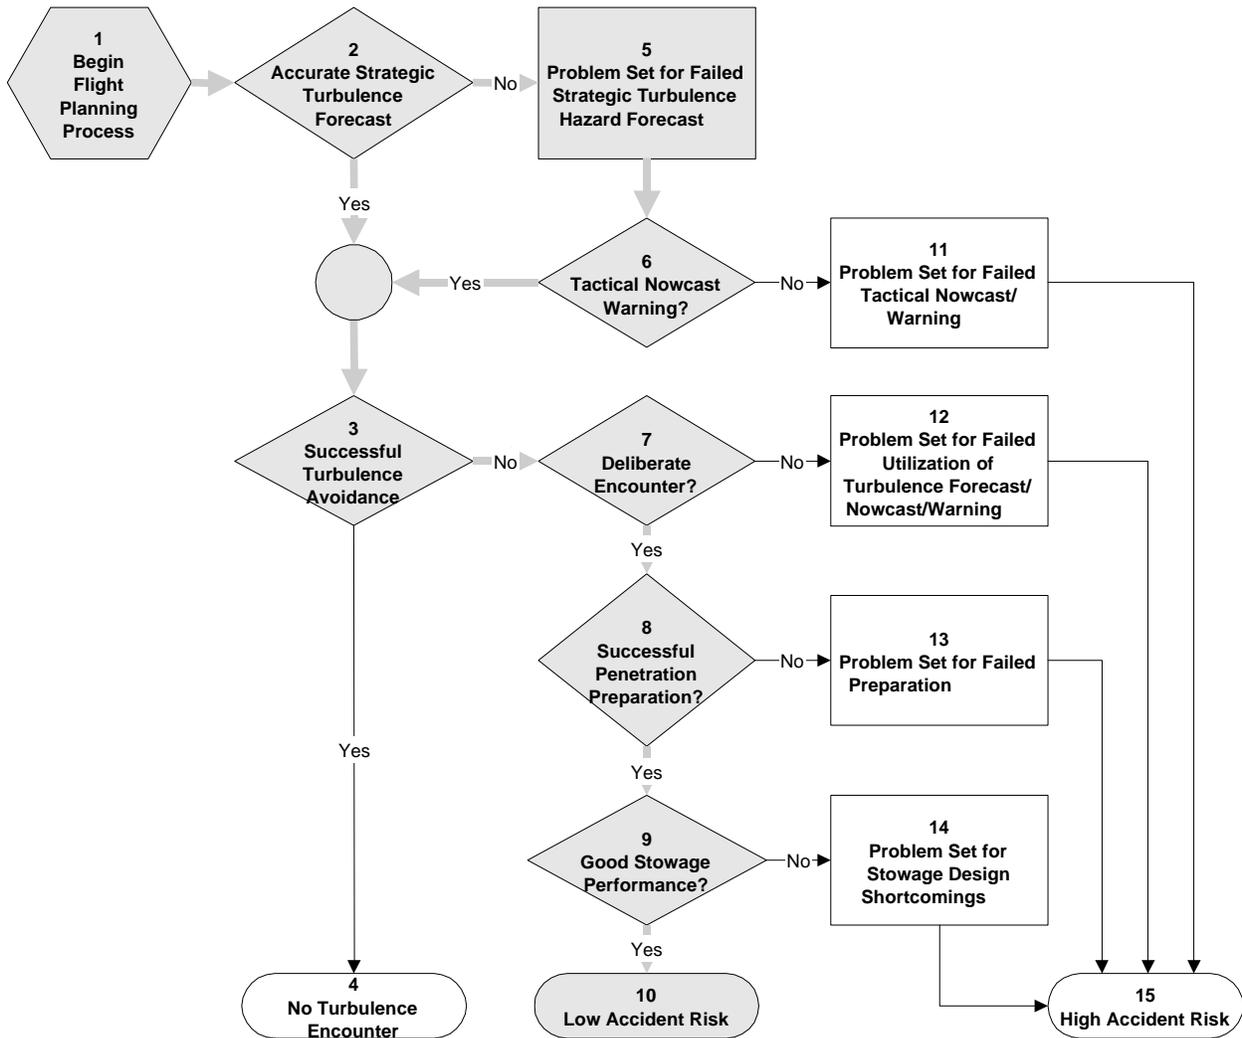
Figure 6b: Turbulence Avoidance and Mitigation Flow Chart -- Low-Risk Scenario

In the high-risk scenario, no warning of turbulence is available to the flight crew, the cabin crew, or the passengers. This scenario comes about due to a total breakdown in producing, communicating or heeding turbulence forecasts or

warnings so that the turbulence encountered is completely unanticipated. Path 1,2,3,7,12,15; path 1,2,3,7,8,13,15; path 1,2,3,7,8,9,14,15; path 1,2,5,6,11,15; path 1,2,5,6,3,7,12,15; path 1,2,5,6,3,7,8,13,15; and path 1,2,5,6,3,7,8,9,14,15 all lead to the high-risk scenario. Under this scenario, there may be no preparation for a turbulence encounter by flight crew, cabin crew, or passengers. If cabin crew and/or passengers are unsecured, the only measures that can mitigate injuries under this scenario involve aircraft design. Design or redesign measures include passive or automatic controls (which the pilot does not manipulate) to dampen the effects of turbulence, and cabin design for emergency handholds and injury-mitigating surfaces.

Some failures to mitigate injuries in the high-risk scenario are due to aircraft design elements insufficient to mitigate injuries in unanticipated turbulence [SPS #631]. These failures may include:

- Lack of automated flight controls designed to dampen the effects of turbulence without pilot intervention
- Lack of emergency handholds in the cabin for use by cabin crew and passengers who are not seated and restrained during turbulence
- Cabin structures that have hard or angular surfaces, corners or protrusions
- Restraints or overhead bin doors that may fail during turbulence

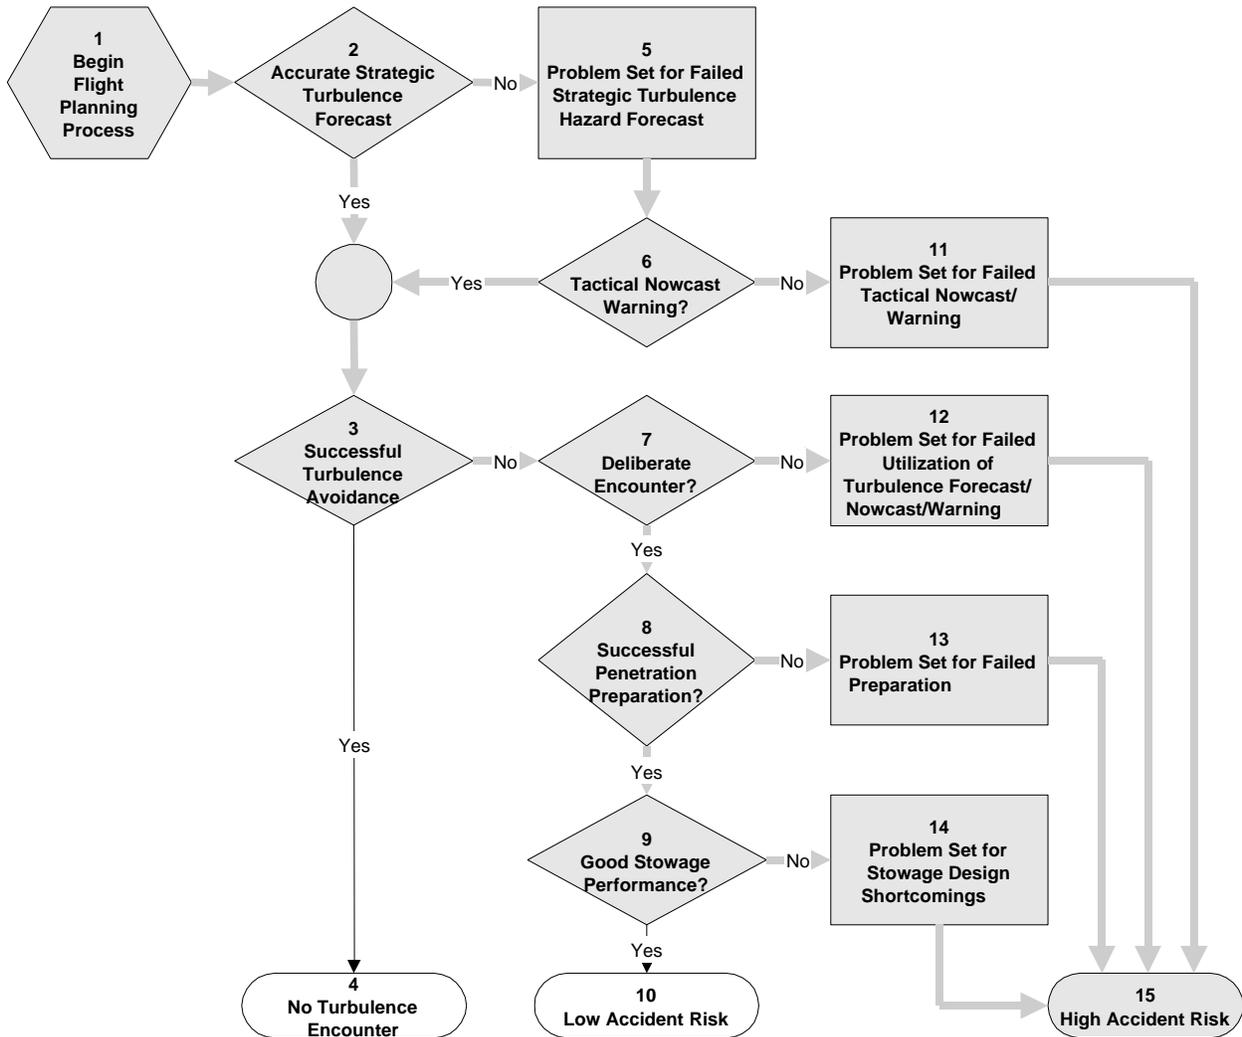
Figure 6c: Turbulence Avoidance and Mitigation Flow Chart -- High-Risk Scenario

The interventions fall into two major categories as depicted in Figure 6c: (1) avoidance of turbulence encounters, and (2) mitigating the impact of turbulence on aircraft occupants. The previous section presented groups of problems associated with different phases of operations in the presence or absence of turbulence information and in the differing ways operators choose to use or not use turbulence information. This section discusses the interventions designed to address those problems.
